Fish Passage & Diversion Screening Inventory Database Report Cover Sheet

Site Description Report

Site ID 996807

Level A Culvert Assessment Report

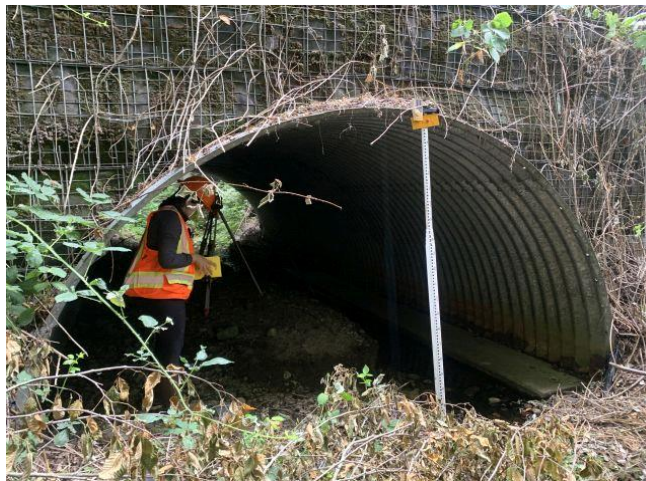
Culvert has LB footing exposed, with the stream flowing on top of it; Measurements taken from thalweg. Reinforced sheer head wall with metal fencing.
